MILLER POND DAM

NDI NO. PA-00159

**PHASE I INSPECTION REPORT
NATIONAL DAM INSPECTION PROGRAM**

Name of Dam: MILLER POND DAM, NDI NO. PA-100159
State & State No.: PENNSYLVANIA, 64-39
County: WAYNE
Stream: TRIBUTARY TO JOHNSON CREEK
Date of Inspection: October 24, 1979

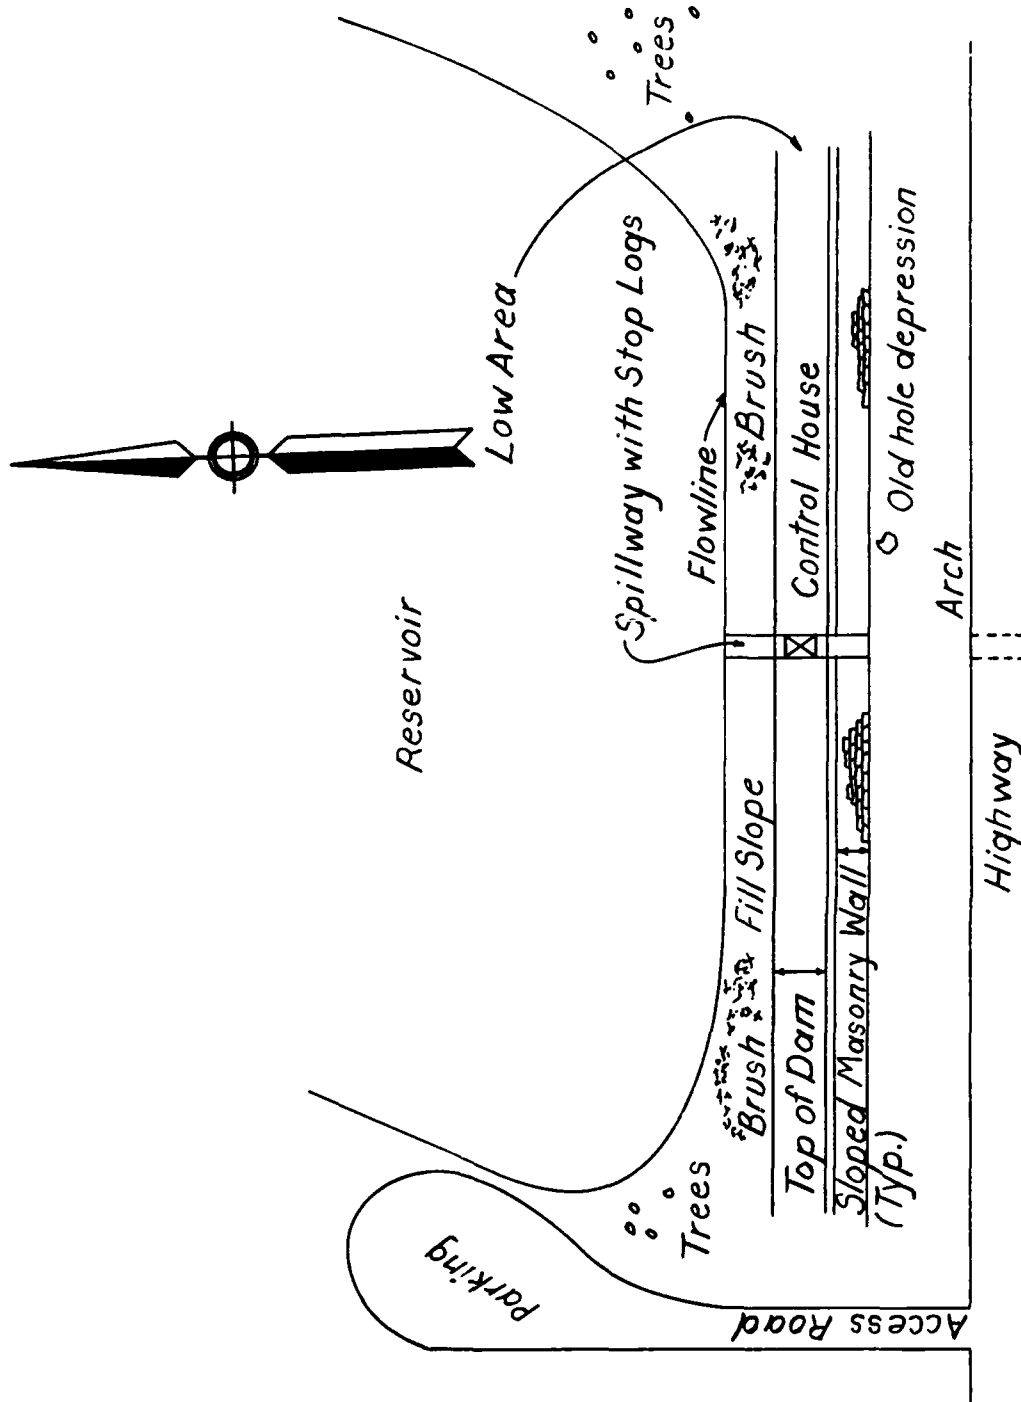
MILLER POND DAM
PA-00159
INSPECTION SURVEY
PLATE A-I

SCHEMATIC PLAN

Surveyed 10-24-79

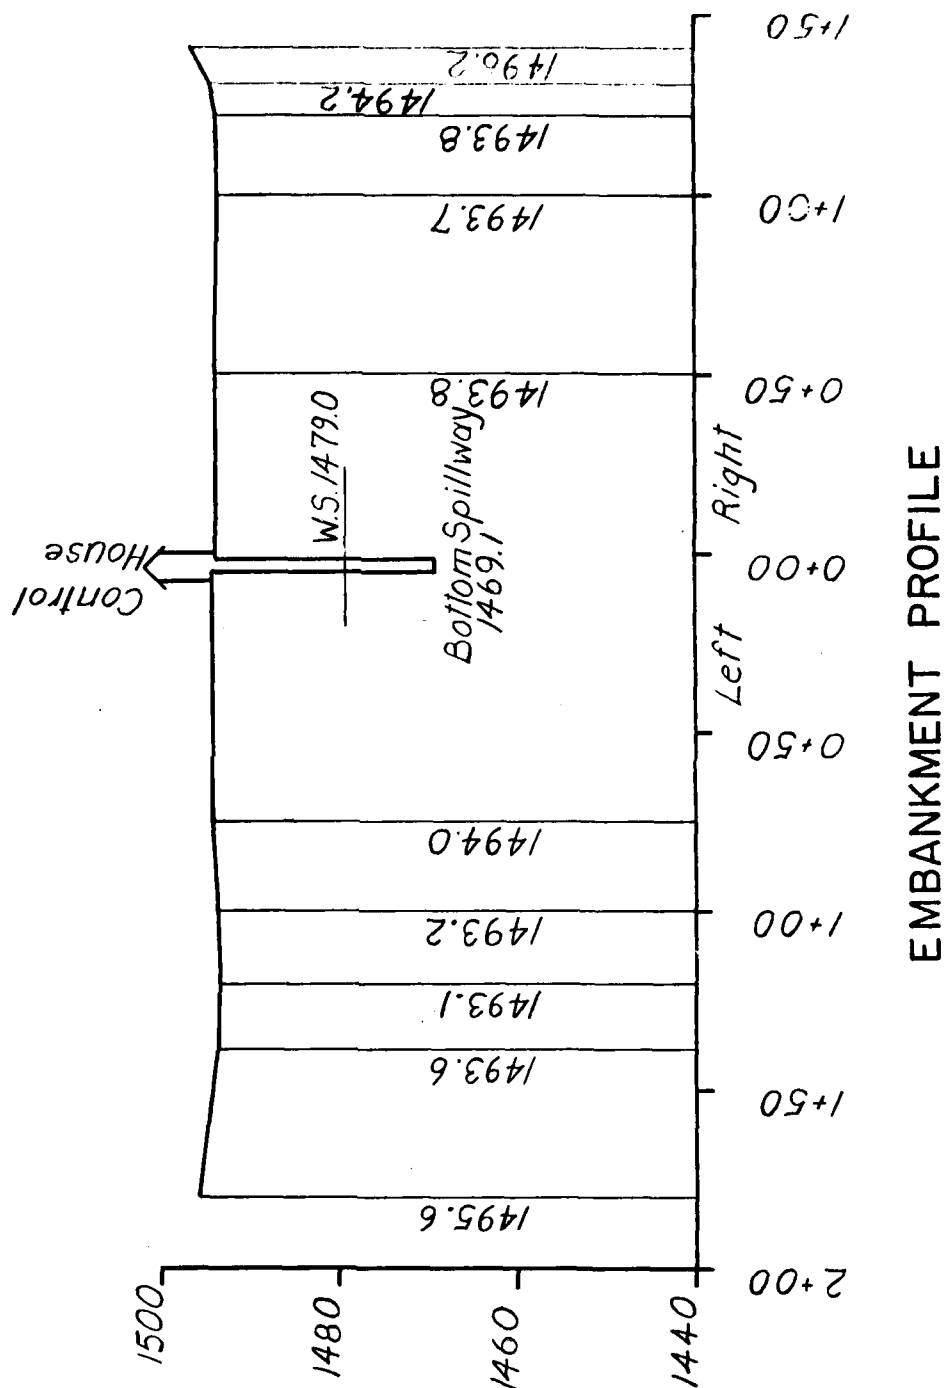
MILLER POND DAM
 PA.-00159
 INSPECTION SURVEY
 PLATE A-II

The upstream slope of the embankment is rather steep (see Plate A-III) and has a considerable growth of brush. The slope is covered with loose stone and appears to be stable. At the left end of the embankment is a low area (refer to profile Plate A-II, Appendix A). The top of the dam is well maintained. The downstream section of the dam consists of a loose, handlaid dry stone wall with a slope of about 0.5H to 1V. The wall appears to be sound. Evidence of seepage was not detected. About twenty feet to the left of the outlet structure, a small depression was noticed in front of the wall. This depression has been there for many years.
